GT2002-XX

Characterization of Ceramic Matrix Composite Fasteners Exposed in a Combustor Liner Rig Test

Michael Verrilli and David Brewer

NASA Glenn Research Center
Cleveland, OH

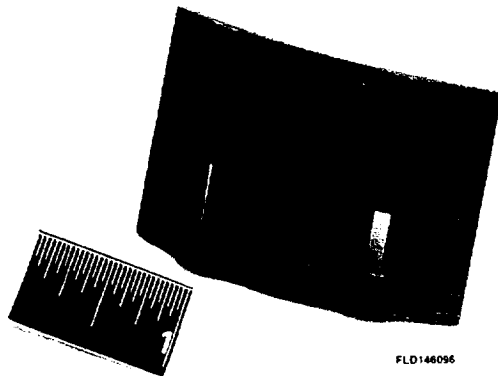
Figure 9 – Lean Transition Liners, a) as-manufactured part, b) installed in the sector rig.

The effect of exposure time can be seen by examining data for fasteners that attached one combustor liner part, the lean transition liner (LTL). The RQL sector rig liner set consisted of twelve LTL's, each held in place with two Miller fasteners, Fig. 9. The exposure temperatures of the different liner parts in the sector rig varied. In addition, combustion gas chemistry and flow rate varied in different regions of the rig. Examination of fastener data for only one part can eliminate potential failure load differences due to varying exposure conditions. During the course of the 260 hours of rig operation, several of the LTL's and their fasteners were removed for reasons described earlier, resulting in the largest number of fasteners exposed for different times from a single part type. To eliminate the effect of failure mode on failure load, only data for LTL fasteners that failed via shear of the “ears” is shown as a function of exposure time in Fig. 10. Data for the as-manufactured fasteners is shown as well. Exposure of 50 hours reduced failure loads by

50% relative to the as-manufactured fasteners. The average fastener failure load of about 900 N was the same for all exposure times, up to the maximum of 260 hours. Note that during sector testing, LTL fasteners reached a maximum temperature of about 1200 °C at the head surface subjected to combustion flow.
